AGENDA TITLE: Adopt resolution requesting that the San Joaquin County Board of Supervisors establish a 5 mile per hour speed limit on the Mokelumne River from the Woodbridge Dam to Guild Avenue

Re: Lodi Lake Nature Area Erosion Along Mokelumne River

Current Site Conditions

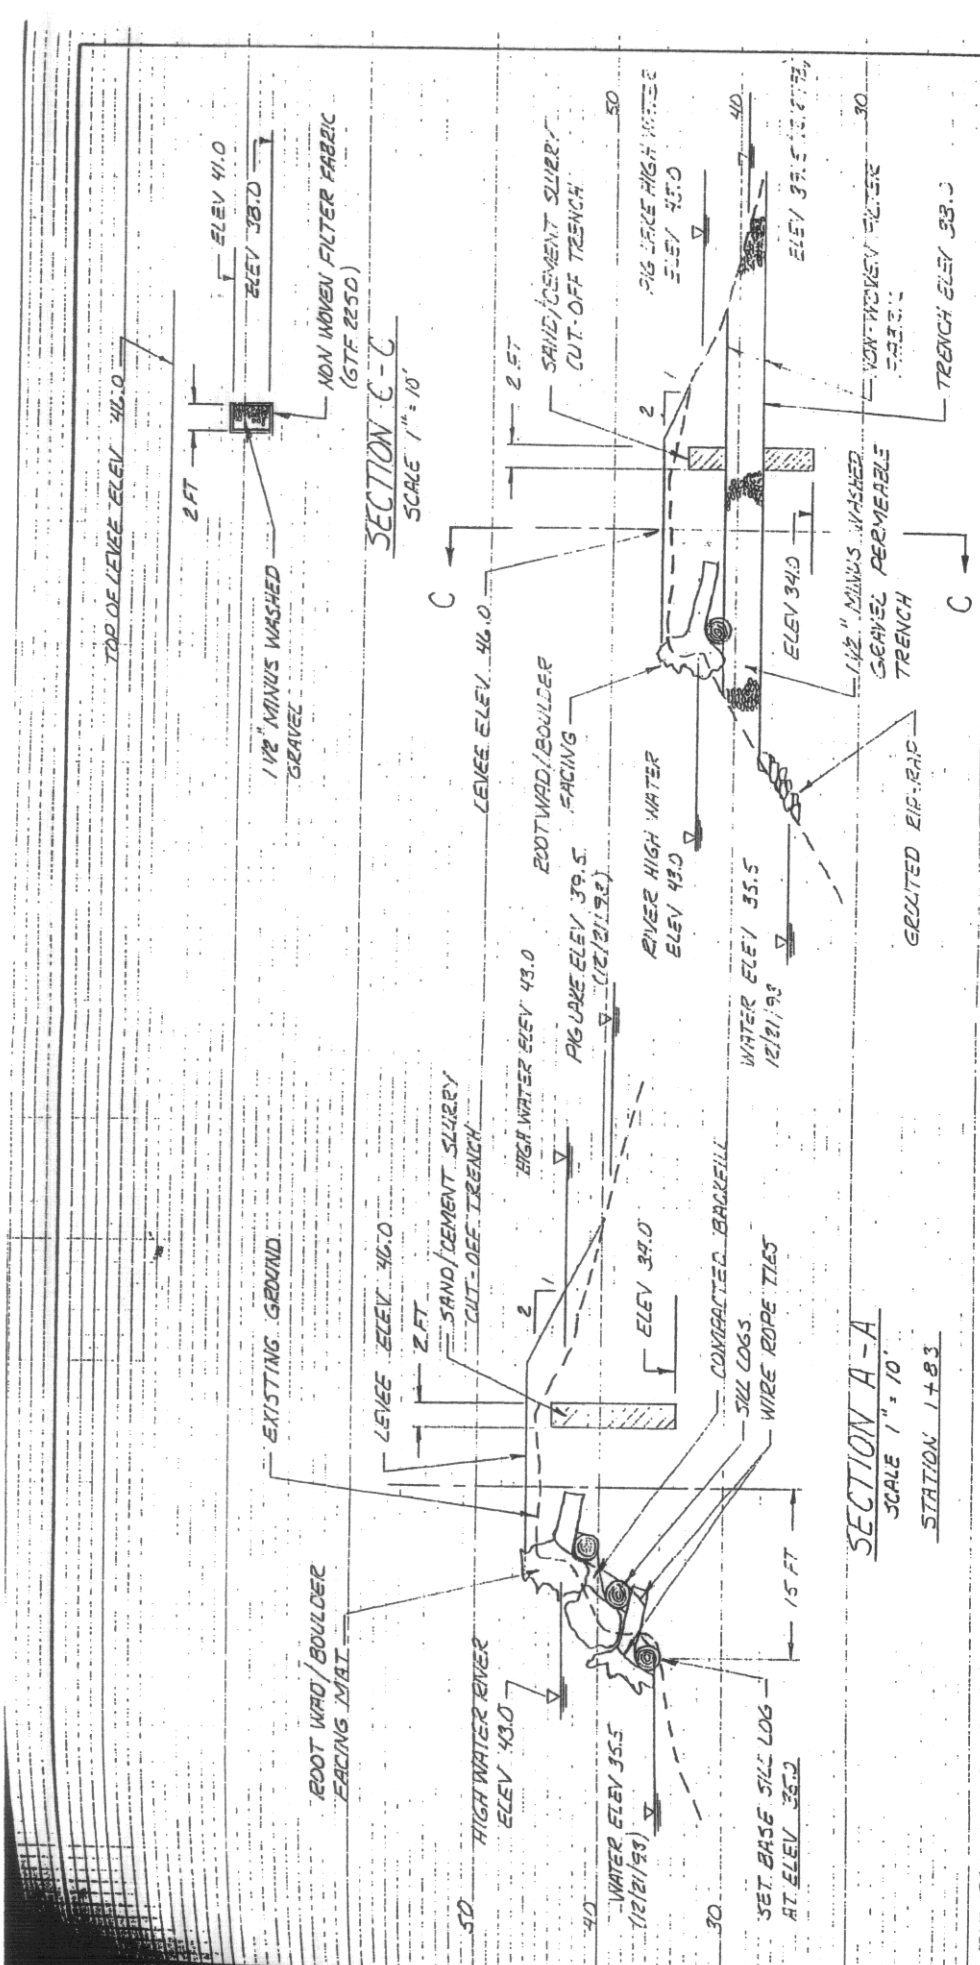
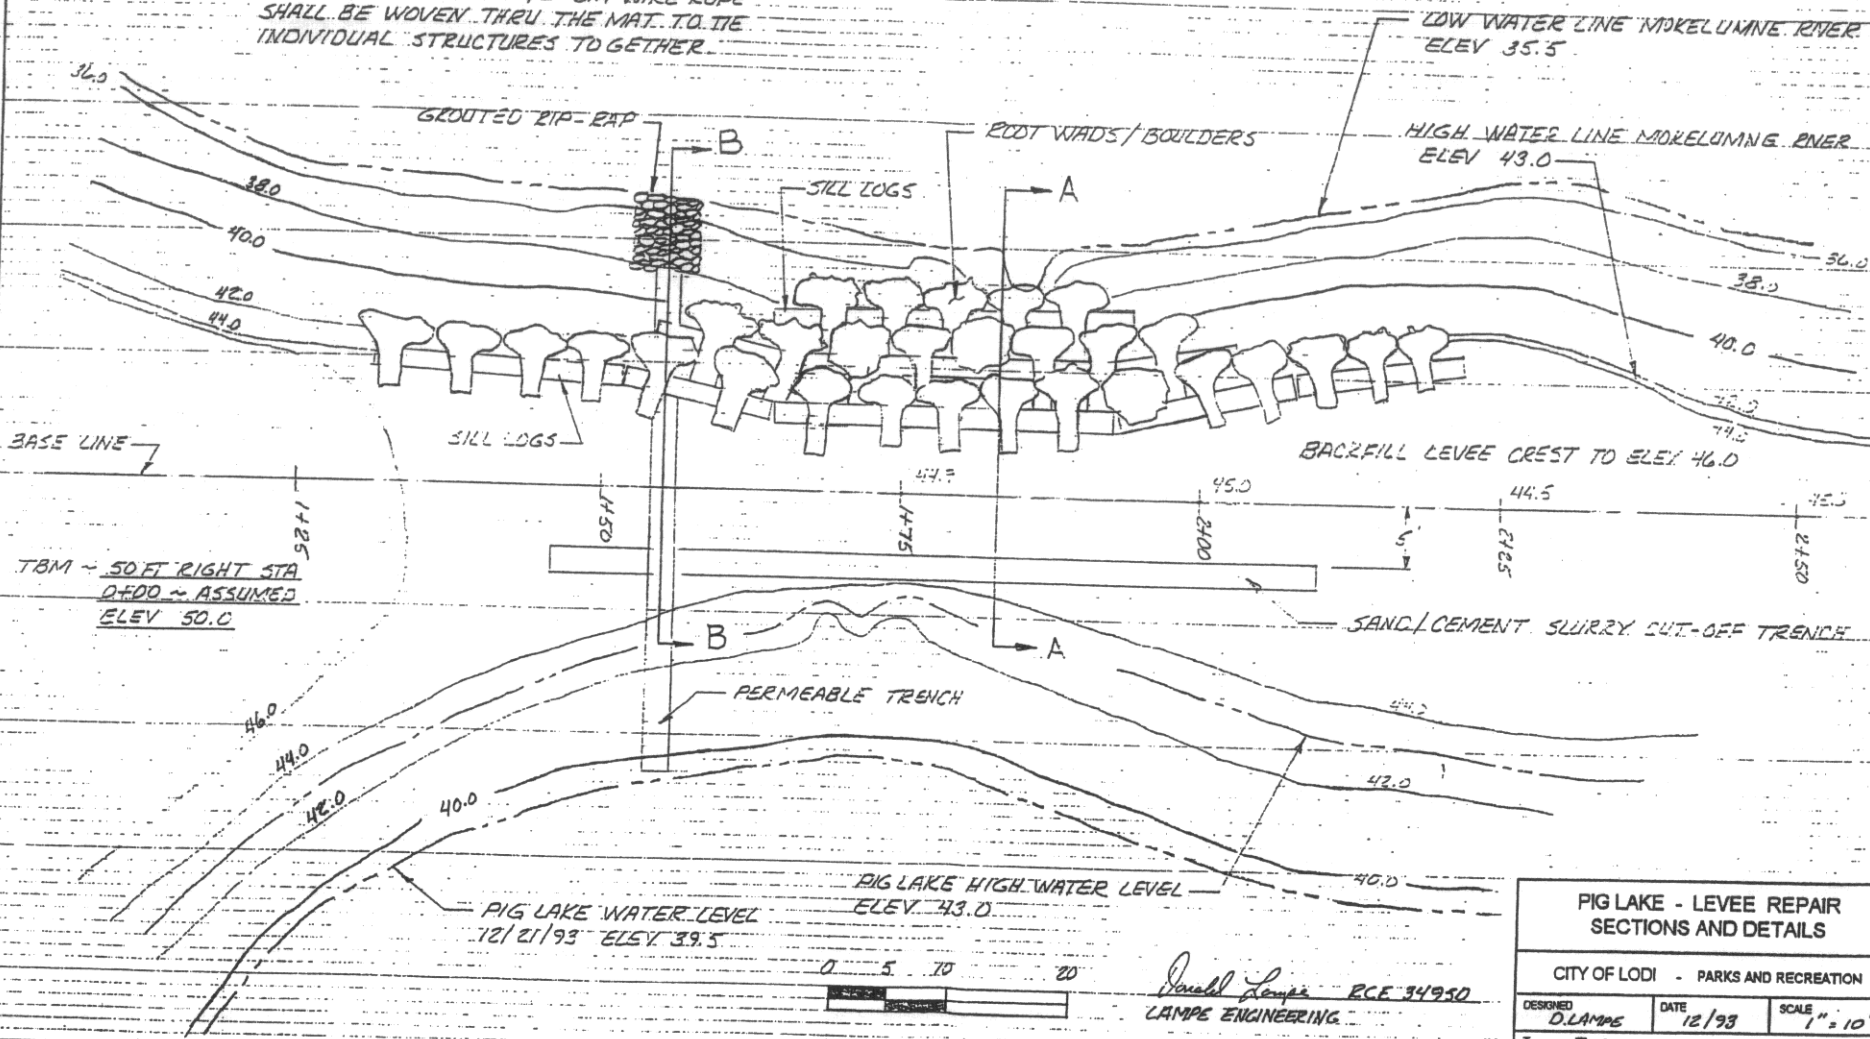
PIG LAKE - LEVEE REPAIR PLAN SHEET			
CITY OF LODI - PARKS AND RECREATION	DESIGNED D. LAMPE	DATE 12/1/93	SCALE 1" = 10'
Lampe Engineering

First, there is hydraulic erosion occurring below the waterline that ~~has~~ undermined and washed out a previous repair project that was completed in 1994 (see attached drawings dated 12/93). The erosion ~~area~~ is located on the outside of a bend in the river, where velocities tend to be the greatest. The previous repairs appear to have consisted of stacking a grid of tree roots and logs along the eroded bank and cabling them to existing live trees along the shoreline. Remnants of the trees and logs used for the 1994 ~~repair~~ project remain scattered throughout the river bottom and bank of the site ~~as~~ shown in the attached photos. The remnant trees and logs may be aggravating the hydraulic cutting action of the river as they could be creating eddies and turbulence that are contributing to the erosion of the river bank.

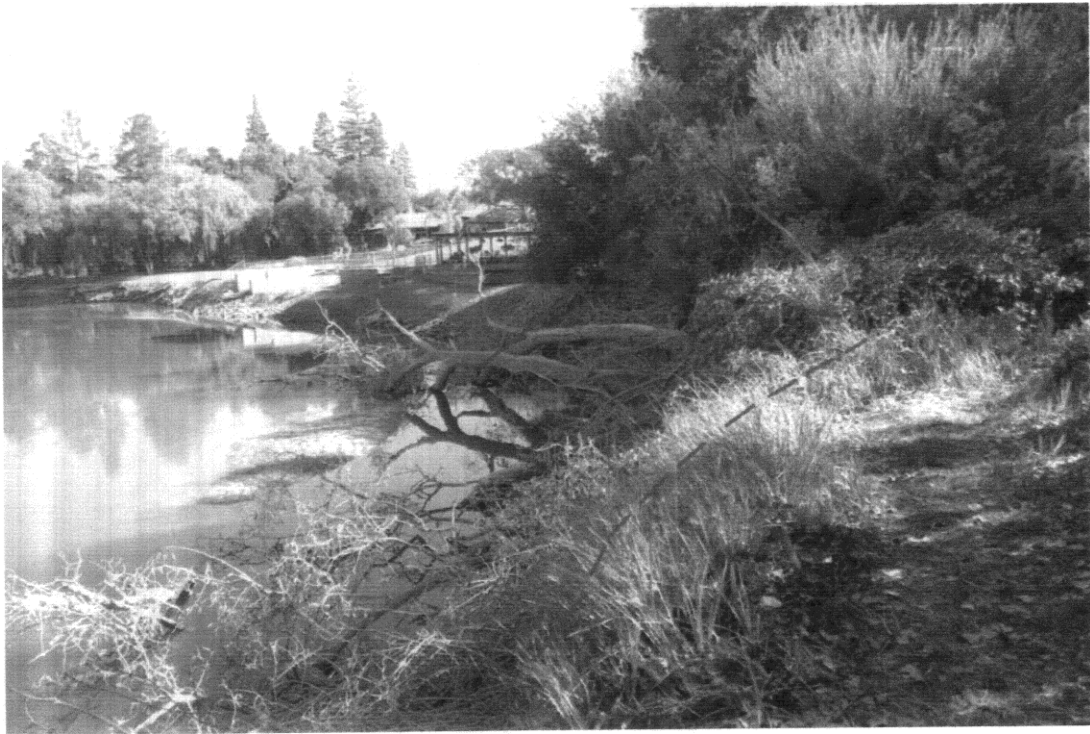
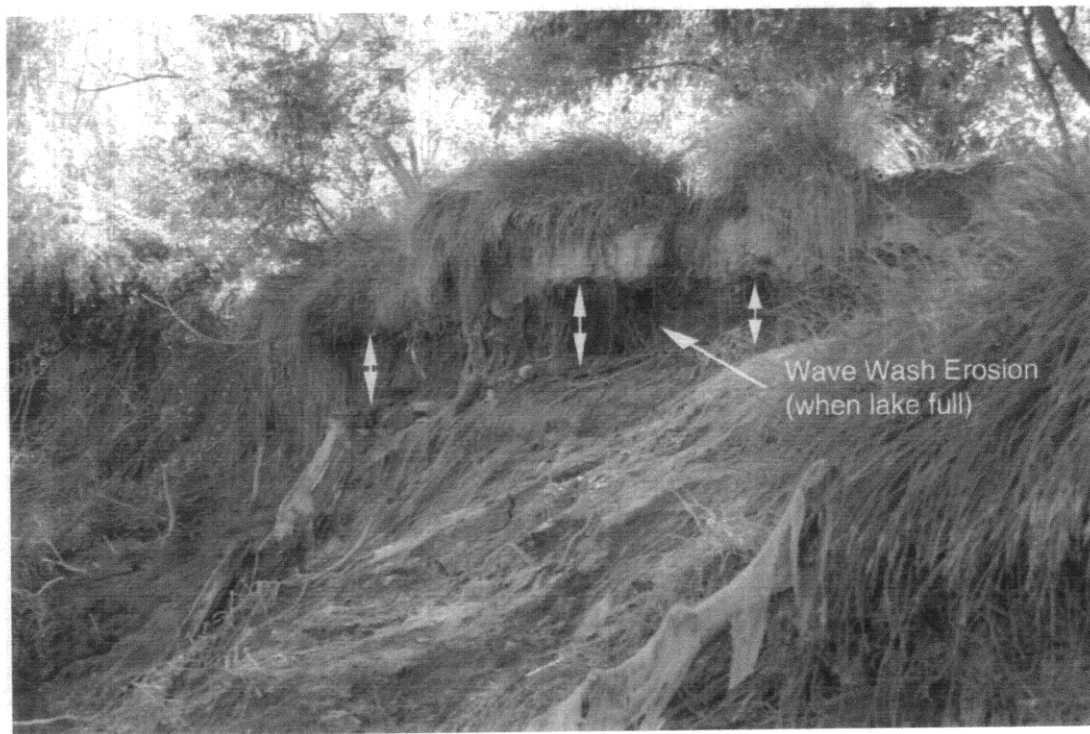
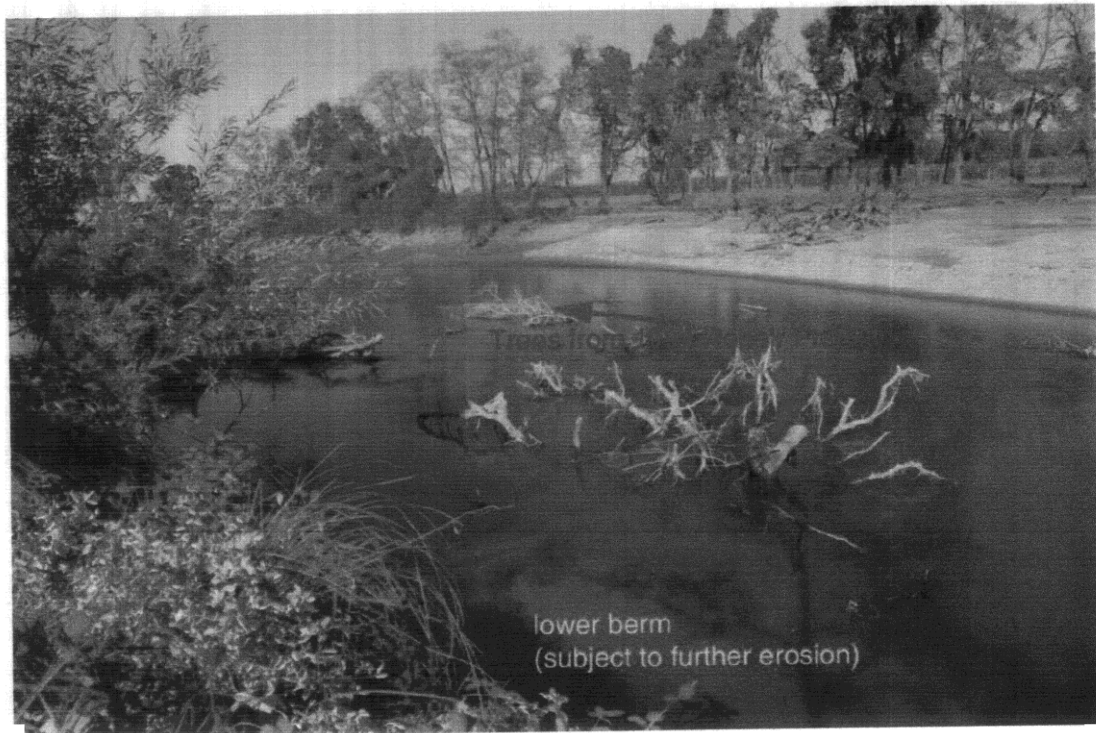
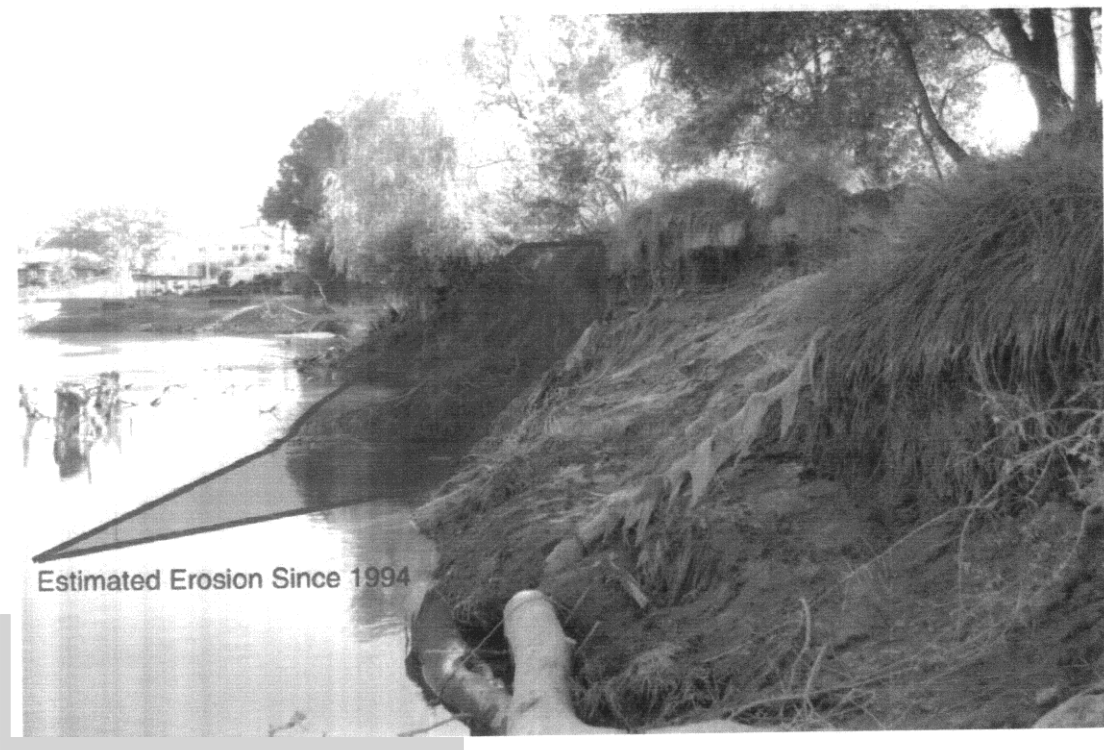
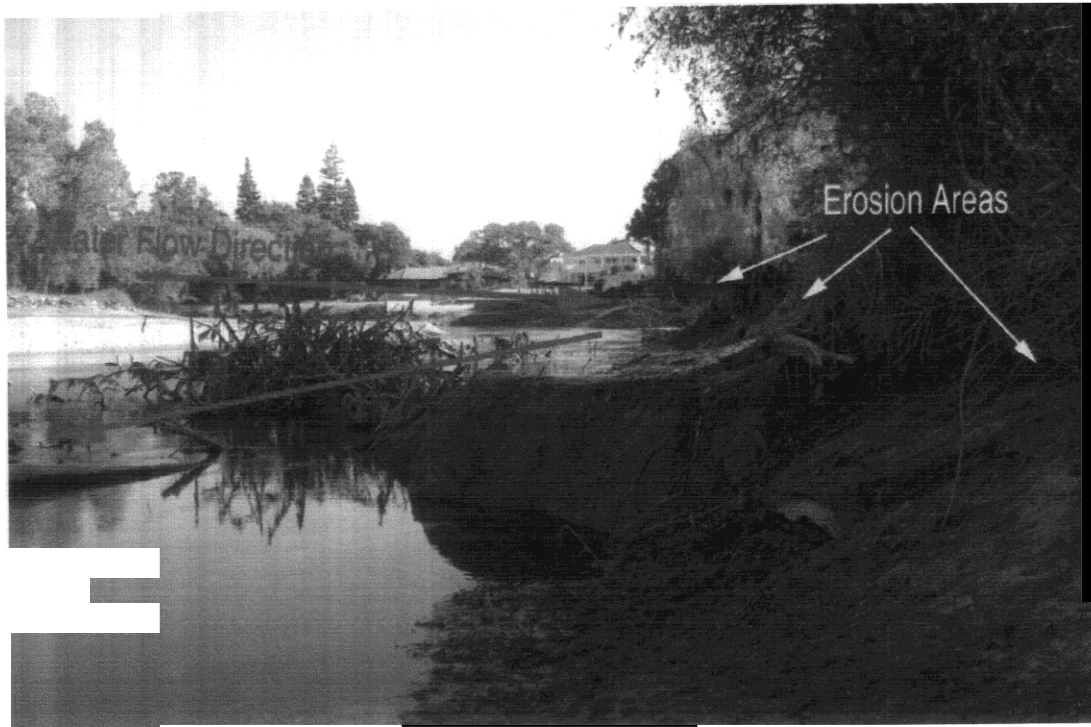
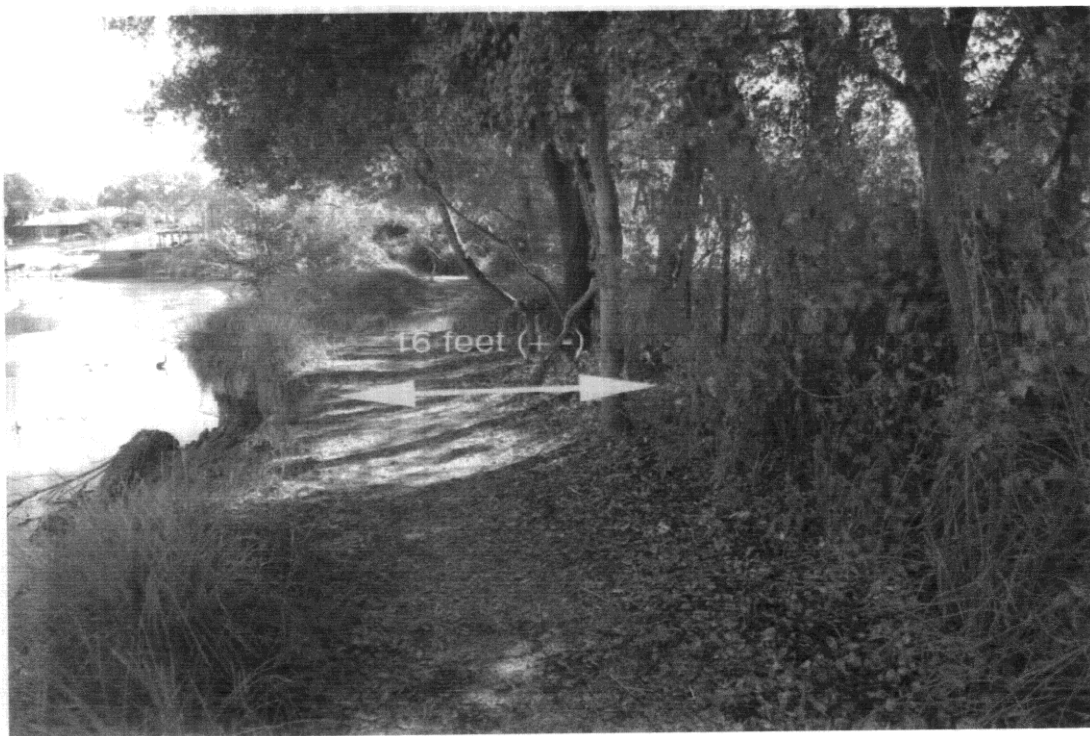
**Lodi Lake Park
Mokelumne River/Pig Lake Erosion Sites**

As shown in the attached photos, erosion has occurred on the right bank **of** the Mokelumne River upstream of the Lodi Lake dam in the vicinity of Pig Lake. The erosion site is approximately 300 feet in **length** and is located **just** downstream of a 180 degree bend in the River that **causes** the lower portions of the river bank at the site to be exposed to the hydraulic cutting action of the river. Erosion is occurring higher up on the river bank slope at the waterline due to wave run up from the wakes of watercraft. This wave erosion has caused undercutting of the bank up to 3 feet in some places. The soil at the site is predominately a cohesionless, fine silty sand that **erodes** quite readily.

Second, there appears to be wave wash erosion occurring at the summer water line when Lodi Lake is full. The waves ~~are~~ generated by both boats and wind. This erosion is clearly defined and localized at the top of the waterside slope. The wave wash was observed during the August inspection when watercraft passed the site.

Following a review of the 1994 repair project plans and the inspection observations, it is estimated that approximately 4 to 10 ~~feet~~ of the embankment crest has eroded away. In some places less than 15 feet of riverbank separate the river from Pig Lake.

If the continuing erosion is not addressed, there is a high potential for a breach of the embankment that separates Pig Lake and the Nature Area from the river.

- Evaluate the practicality of interim protective measures to minimize **further** loss of the riverbank.
 - o May be necessary to limit damage this winter

- o Measures to limit erosion until more permanent repairs **can** be permitted
 - Geotechnical fabrics
 - Sand bags
 - Plastic sheeting
 - Thin band of riprap to stabilize slope
